SOCOTEC

PARK SHORE LANDINGS CONDOMINIUM ASSOCIATION, INC.

Subject: Report of Engineering Consulting Services
MILESTONE INSPECTION – PHASE I
205 Park Shore Drive
Naples, Collier County, FL 34103
SOCOTEC Project Number VS233678

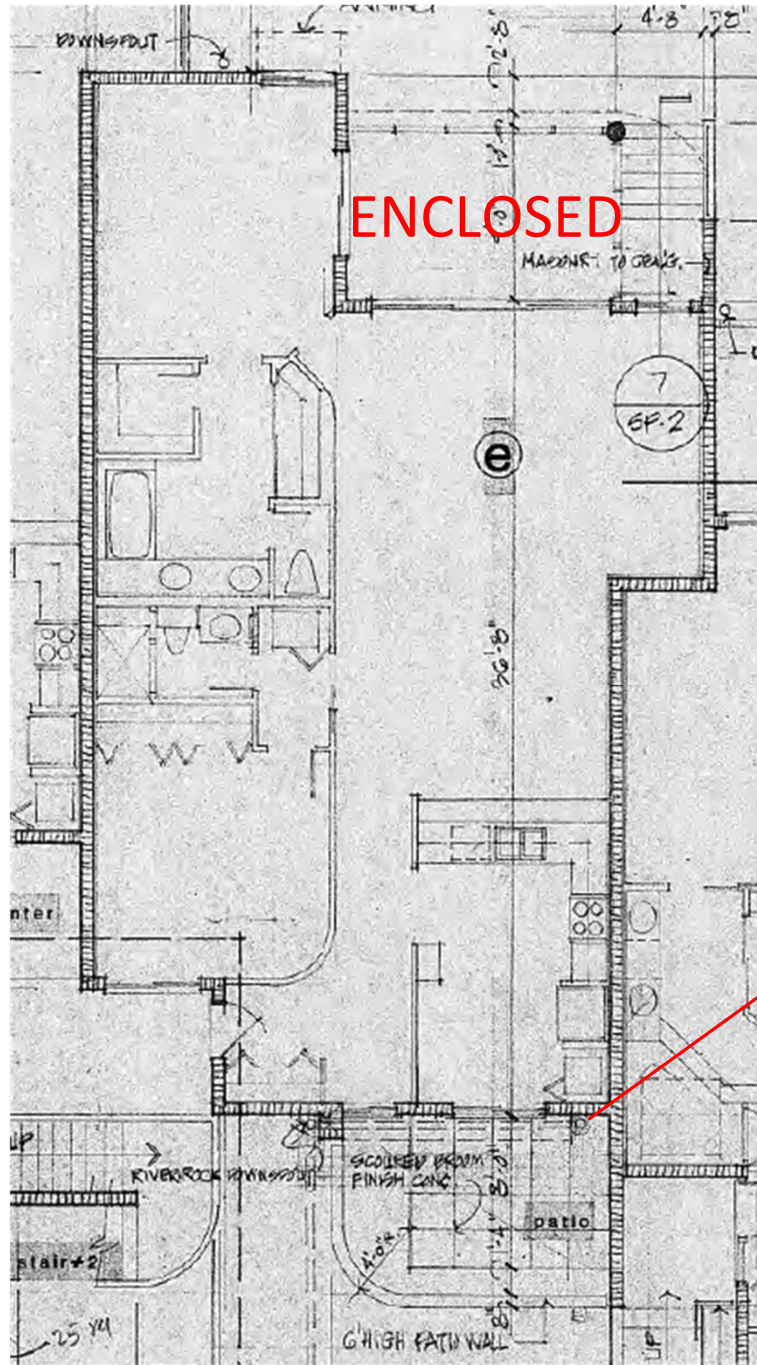
UNIT 411

Hairline crack on wall under dryer vent.

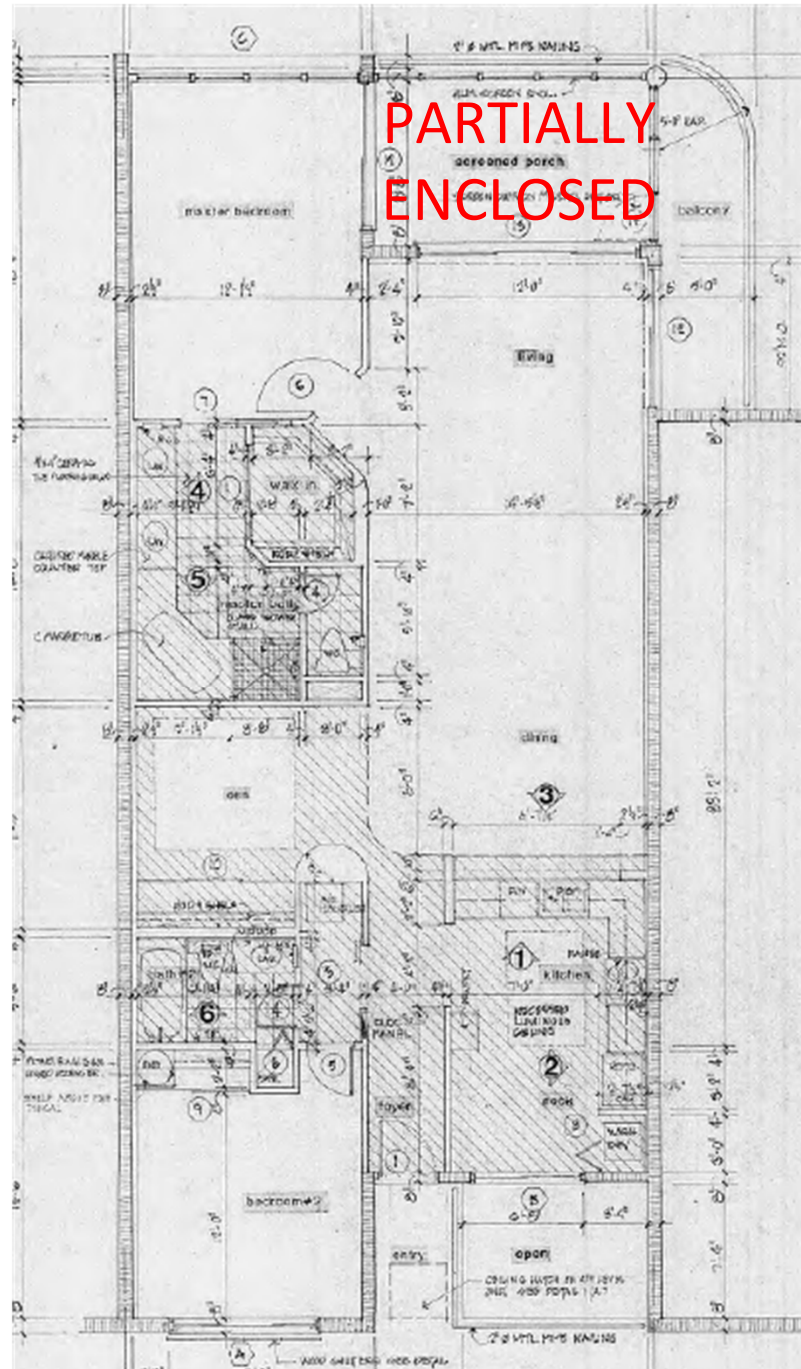
UNIT 422

Hurricane rated
windows and sliders.
Nothing noted.

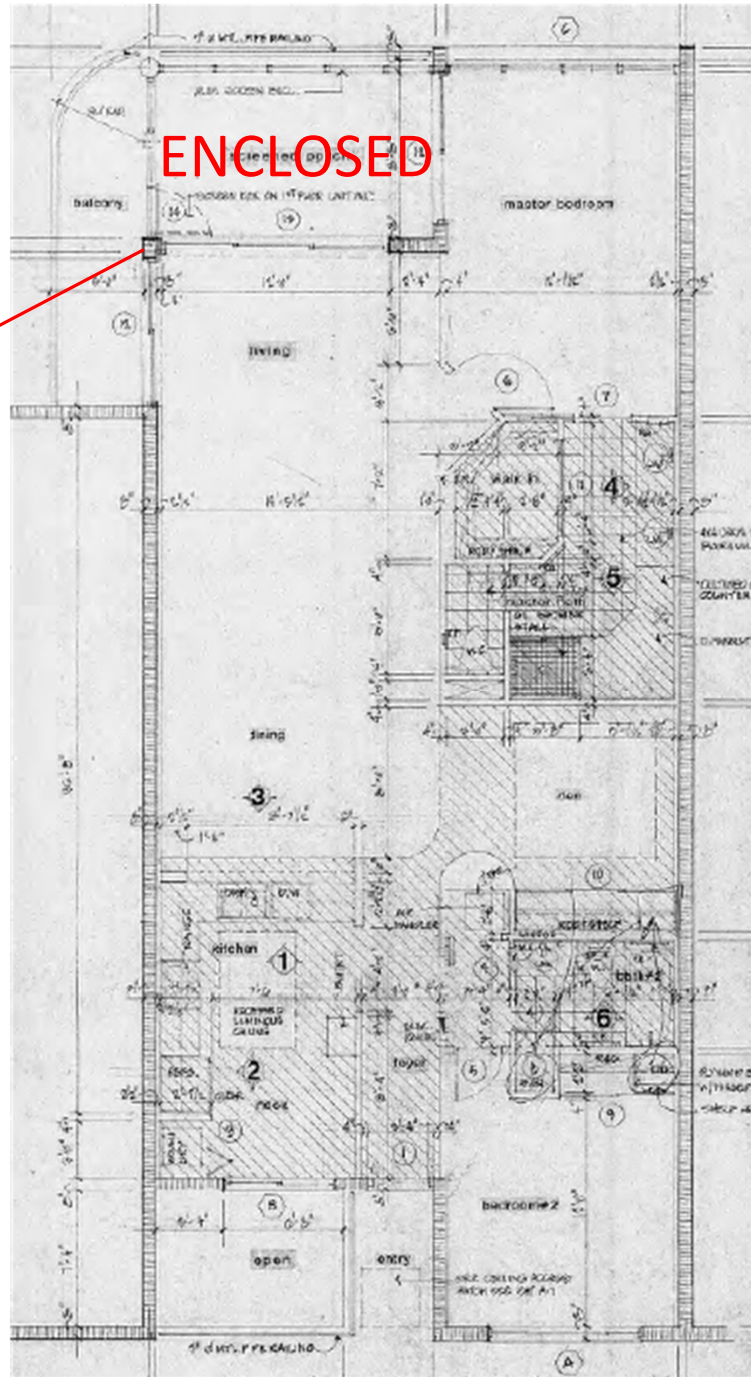
UNIT 433

Spalled concrete at base of column
