SOCOTEC

PARK SHORE LANDINGS CONDOMINIUM ASSOCIATION, INC.

Subject: Report of Engineering Consulting Services
MILESTONE INSPECTION – PHASE I
255 Park Shore Drive
Naples, Collier County, FL 34103
SOCOTEC Project Number VS233678

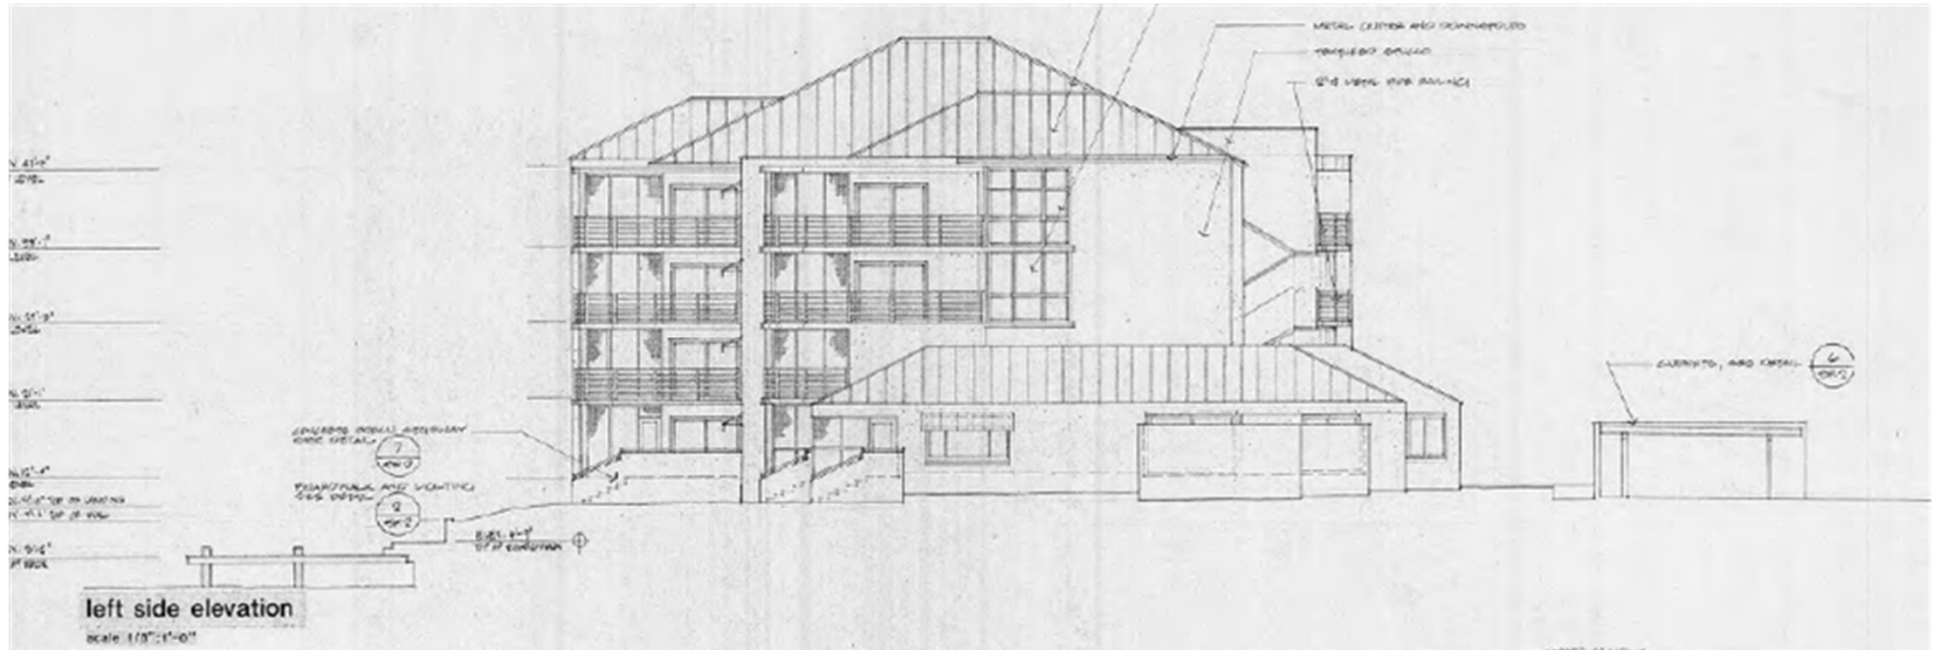
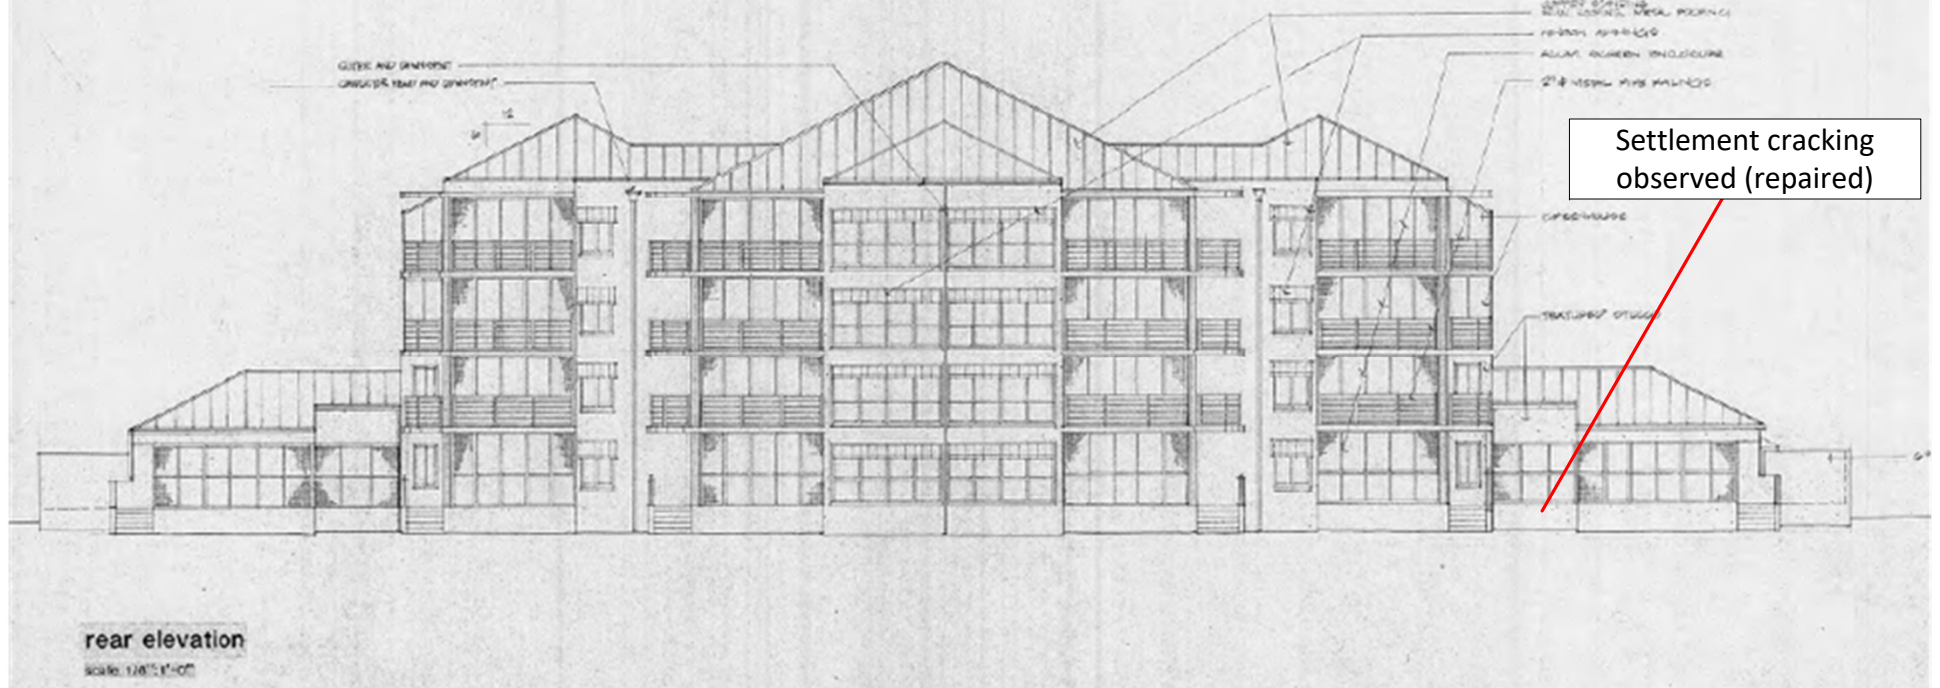
Settlement cracking observed (repaired)

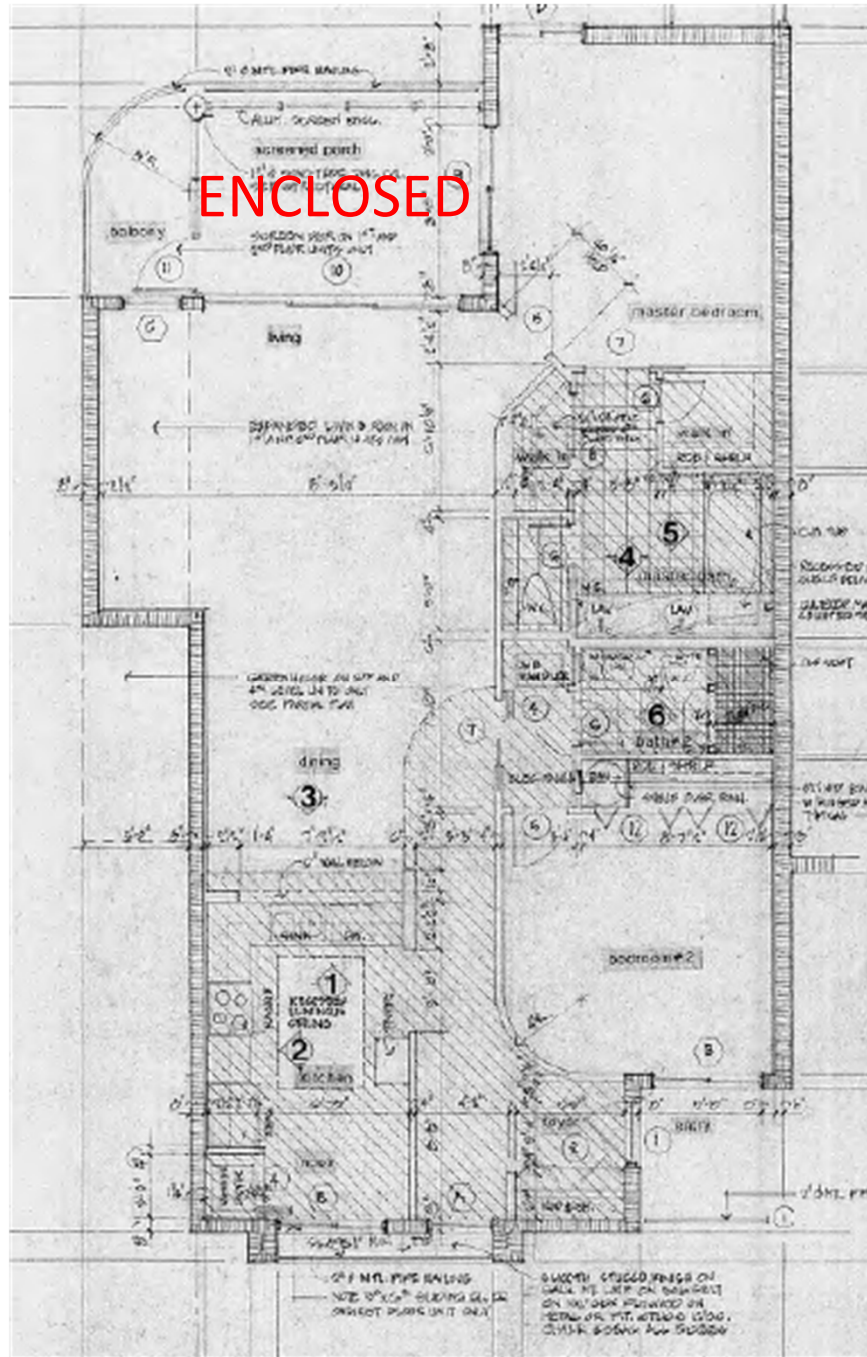
UNIT 314

Hurricane rated windows and sliders. Nothing noted.

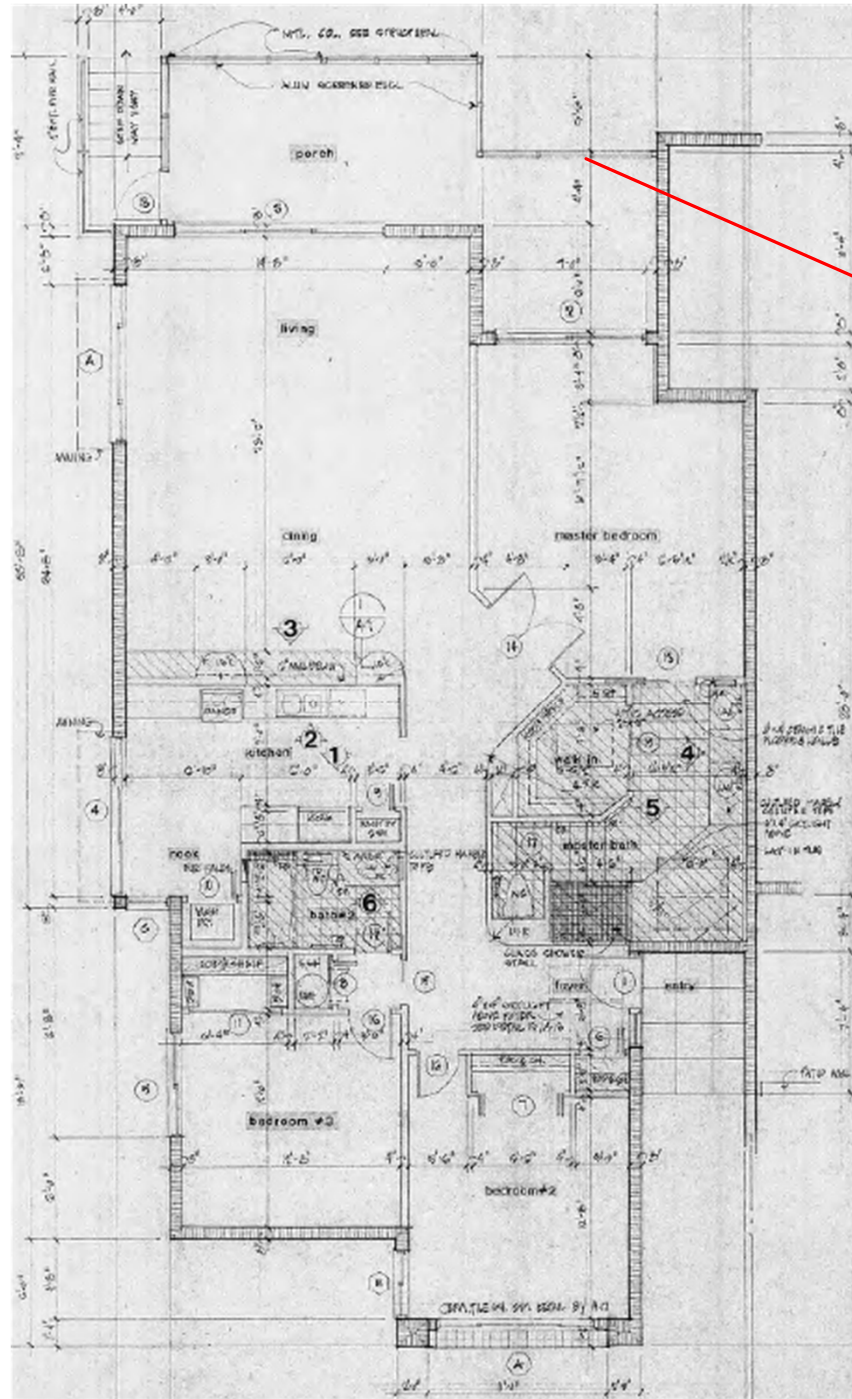
UNIT 315

Repairs made to settlement observed

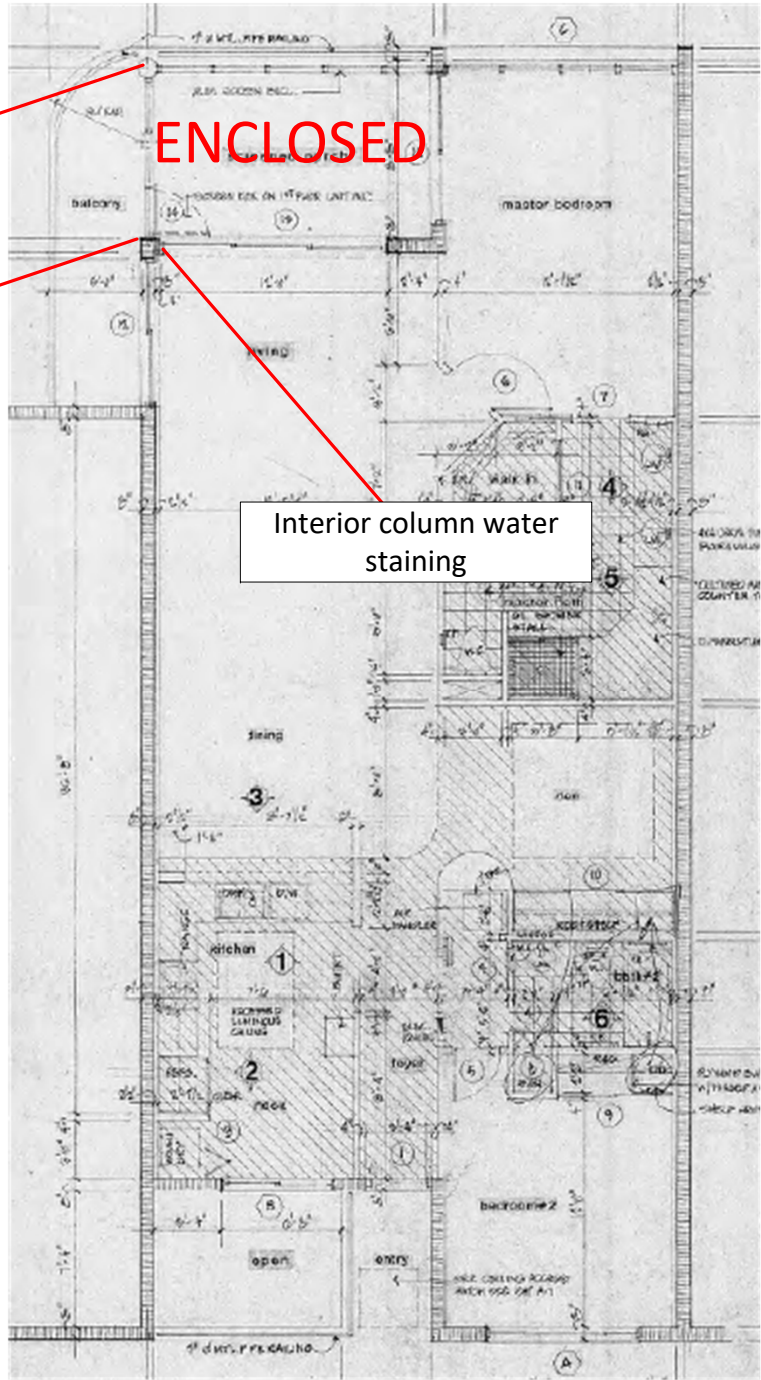
UNIT 323

Multiple cracks observed on exterior column

Small area of spalled concrete at base of exterior column

Interior column water staining

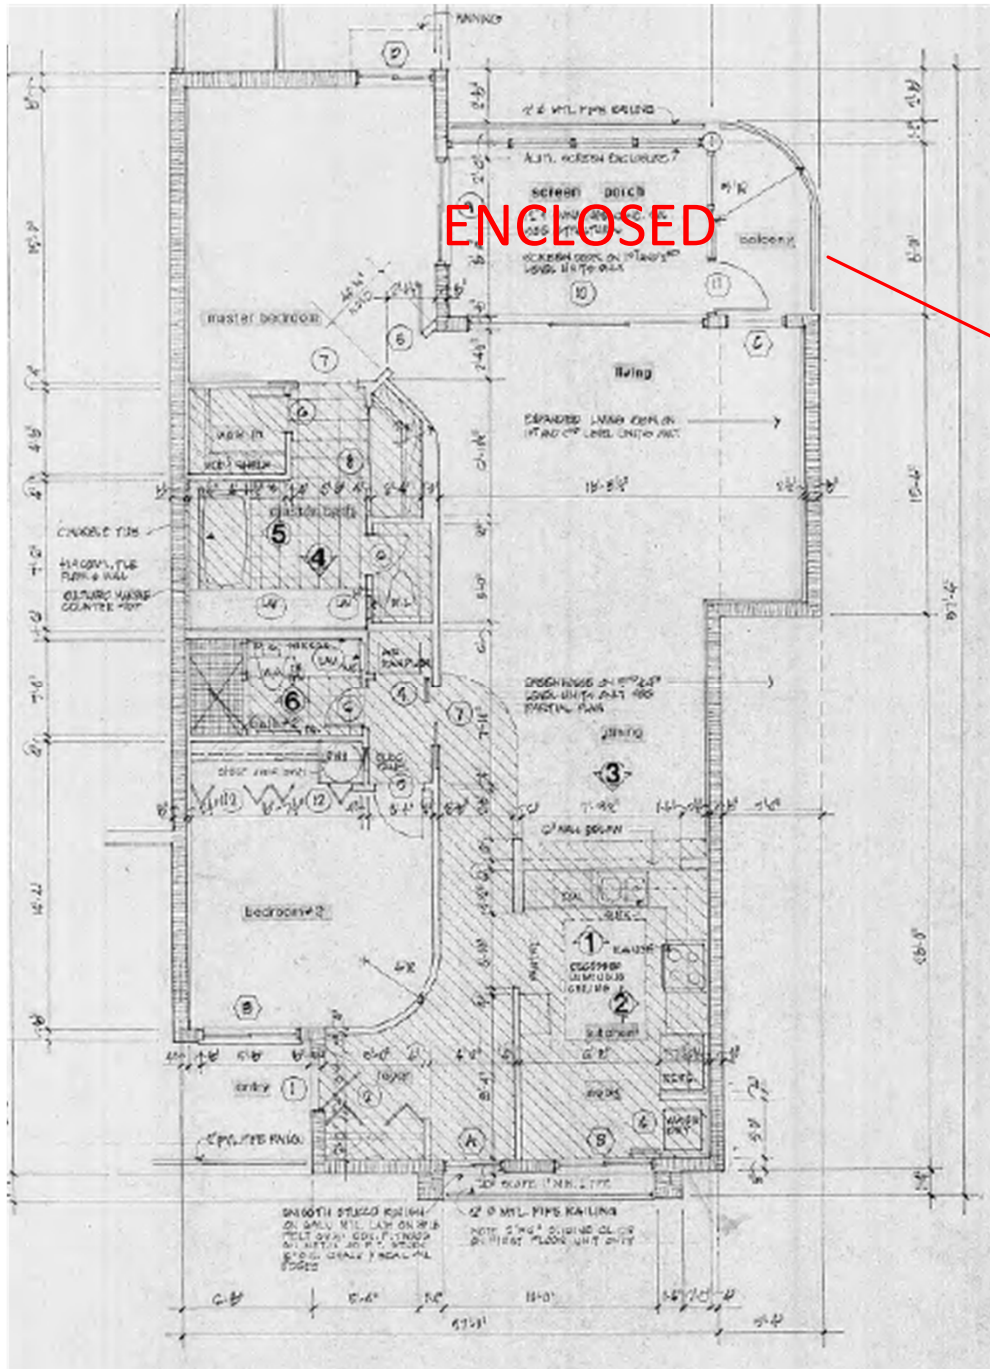
UNIT 331

Small deck edge spalling

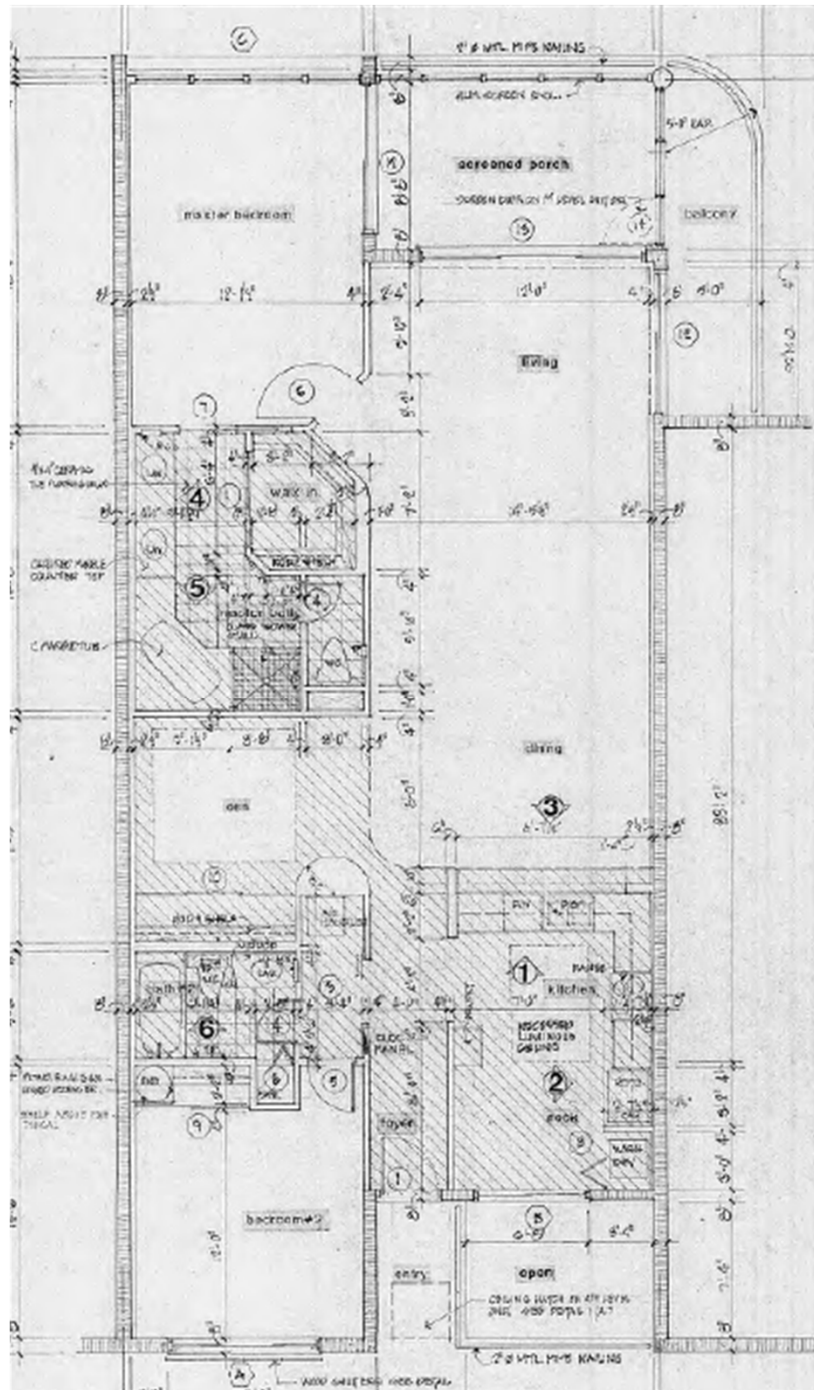
UNIT 342

Older interior sealants
at windows and sliders
