SOCOTEC

April 9, 2024

PARK SHORE LANDINGS CONDOMINIUM ASSOCIATION, INC.

Subject: Report of Engineering Consulting Services
MILESTONE INSPECTION – PHASE I
305 Park Shore Drive
Naples, Collier County, FL 34103
SOCOTEC Project Number VS233678

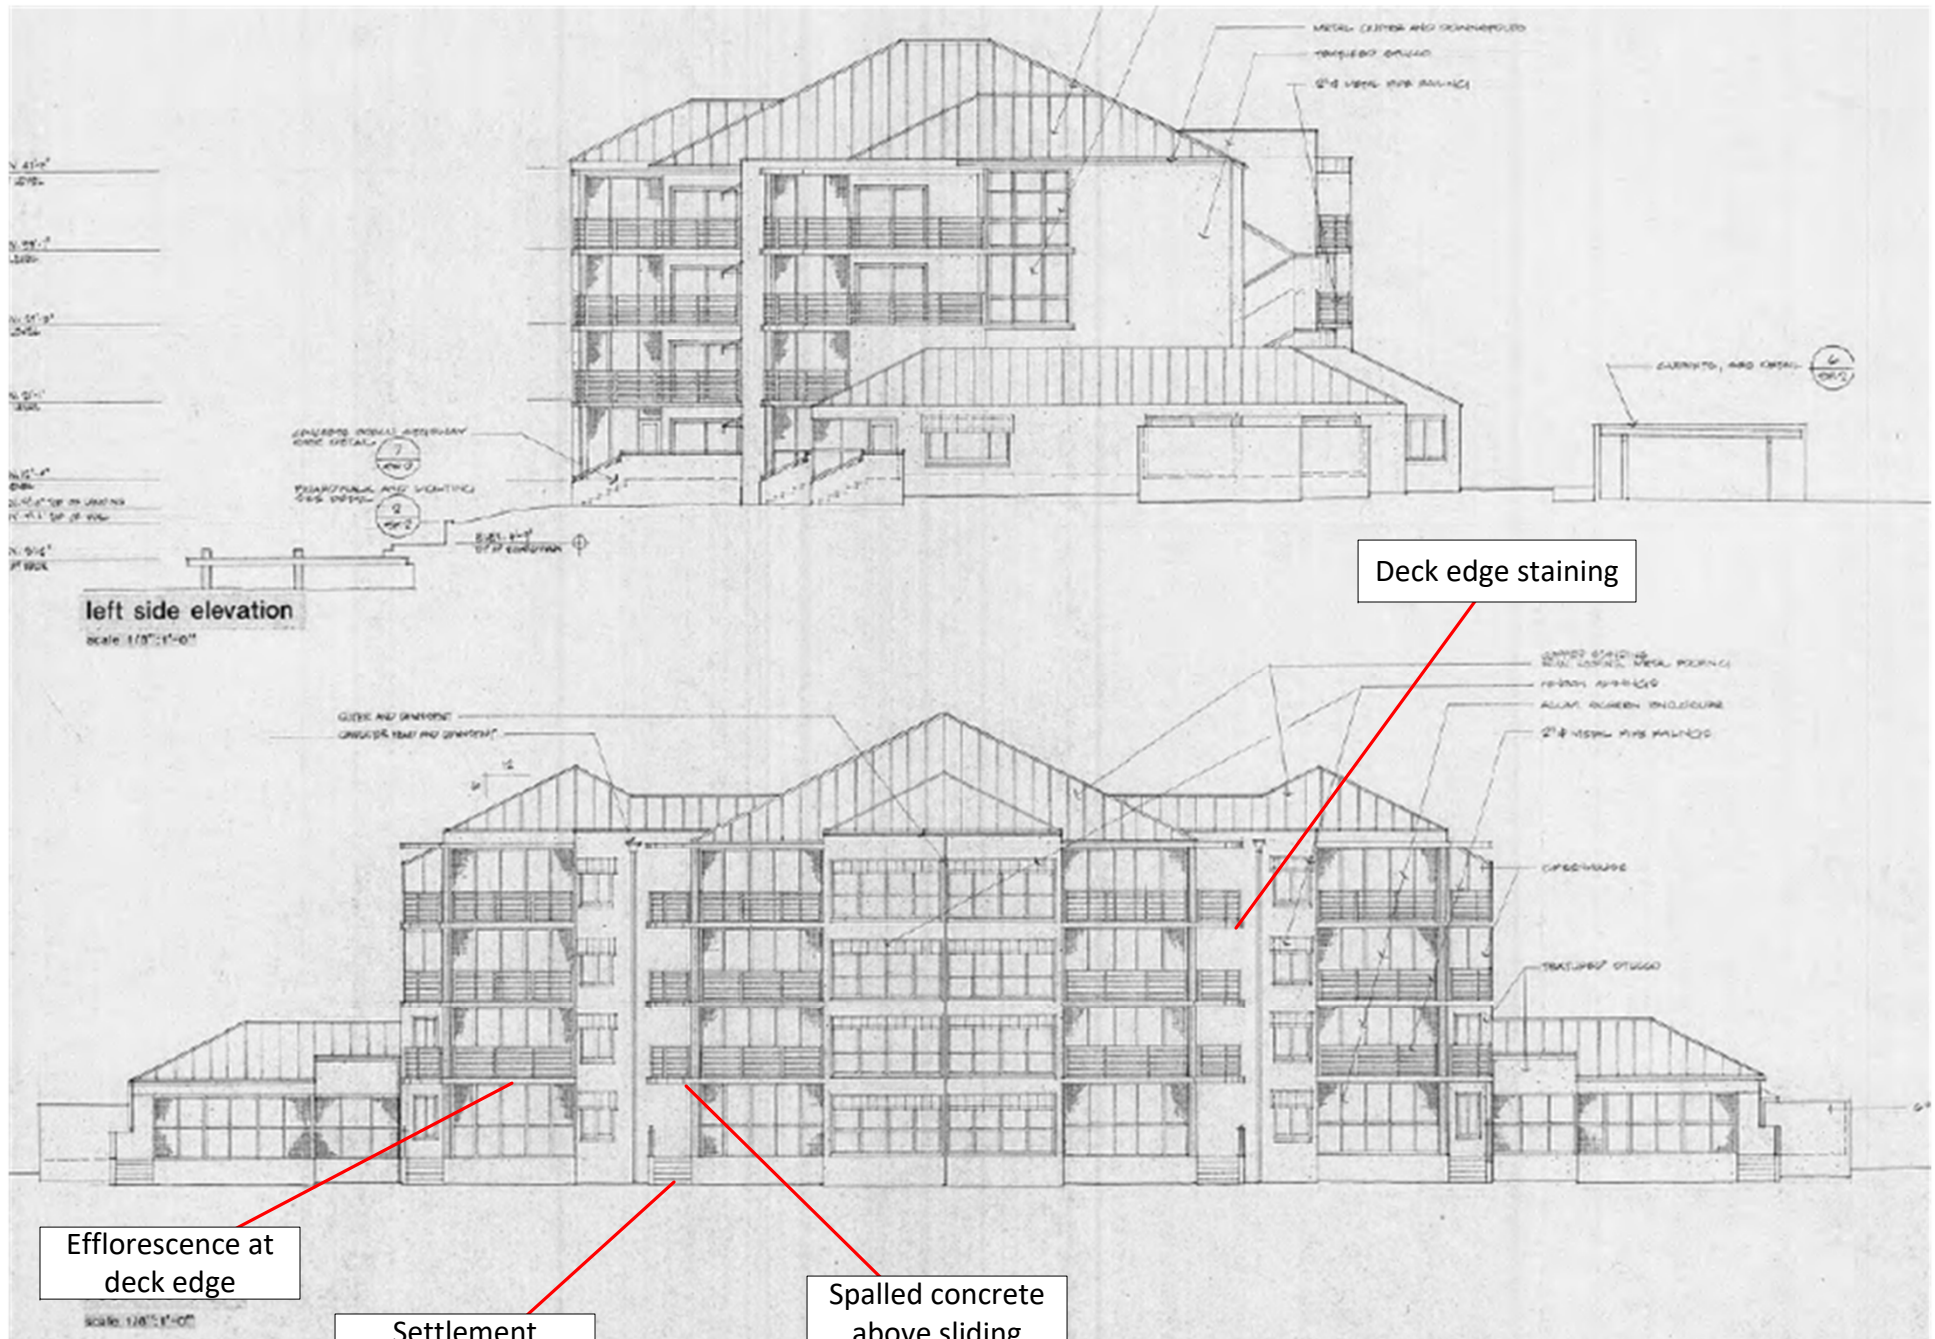
Deck edge staining

Efflorescence at deck edge

Settlement observed on exterior stairs

Spalled concrete above sliding glass door

- Waterproofing decks and deck edges.
- Spalling concrete on the ceiling.
- Signs of previous staining on several balcony edges.
- Deck waterproofing and delaminated tiles.

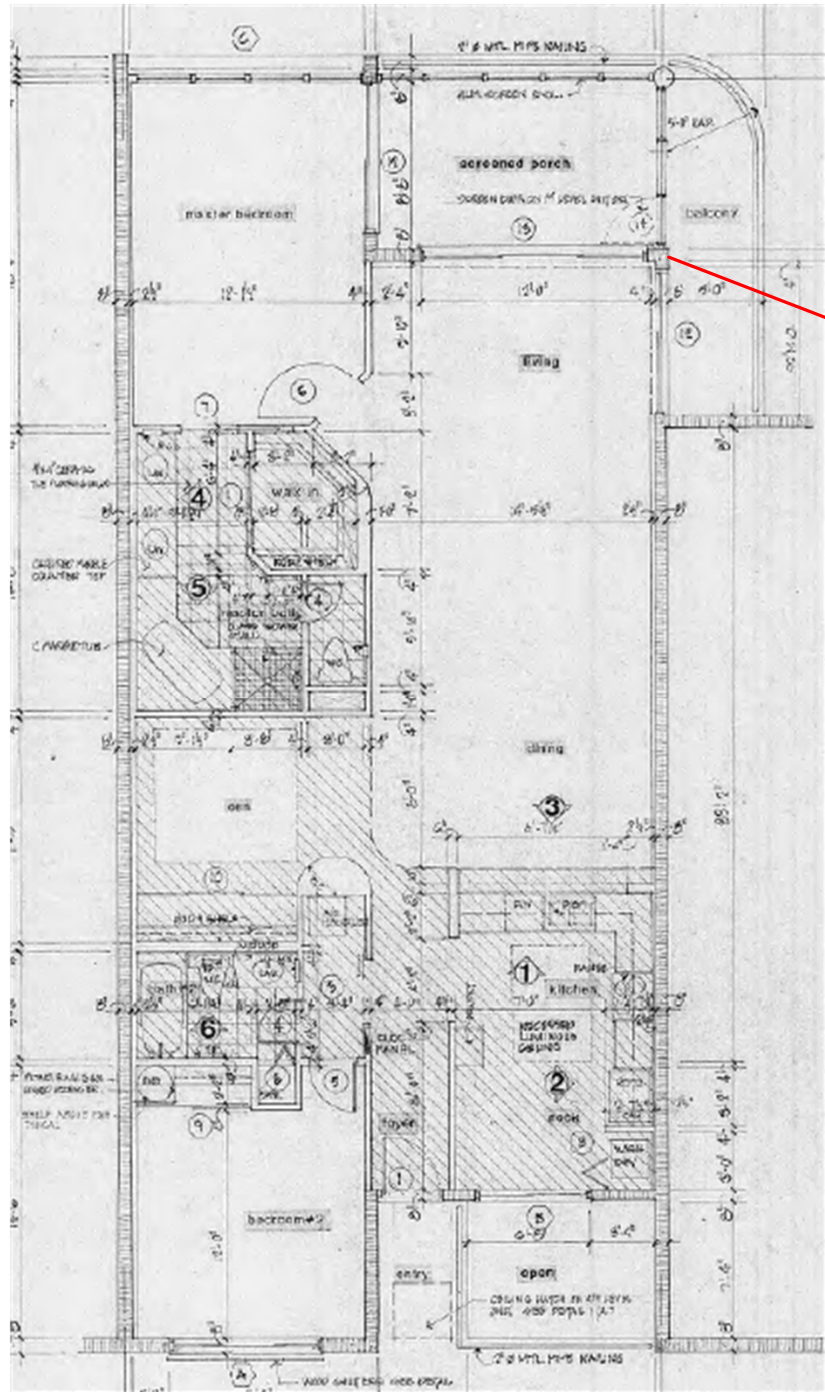
UNIT 212

Crack on base of column and concrete deck

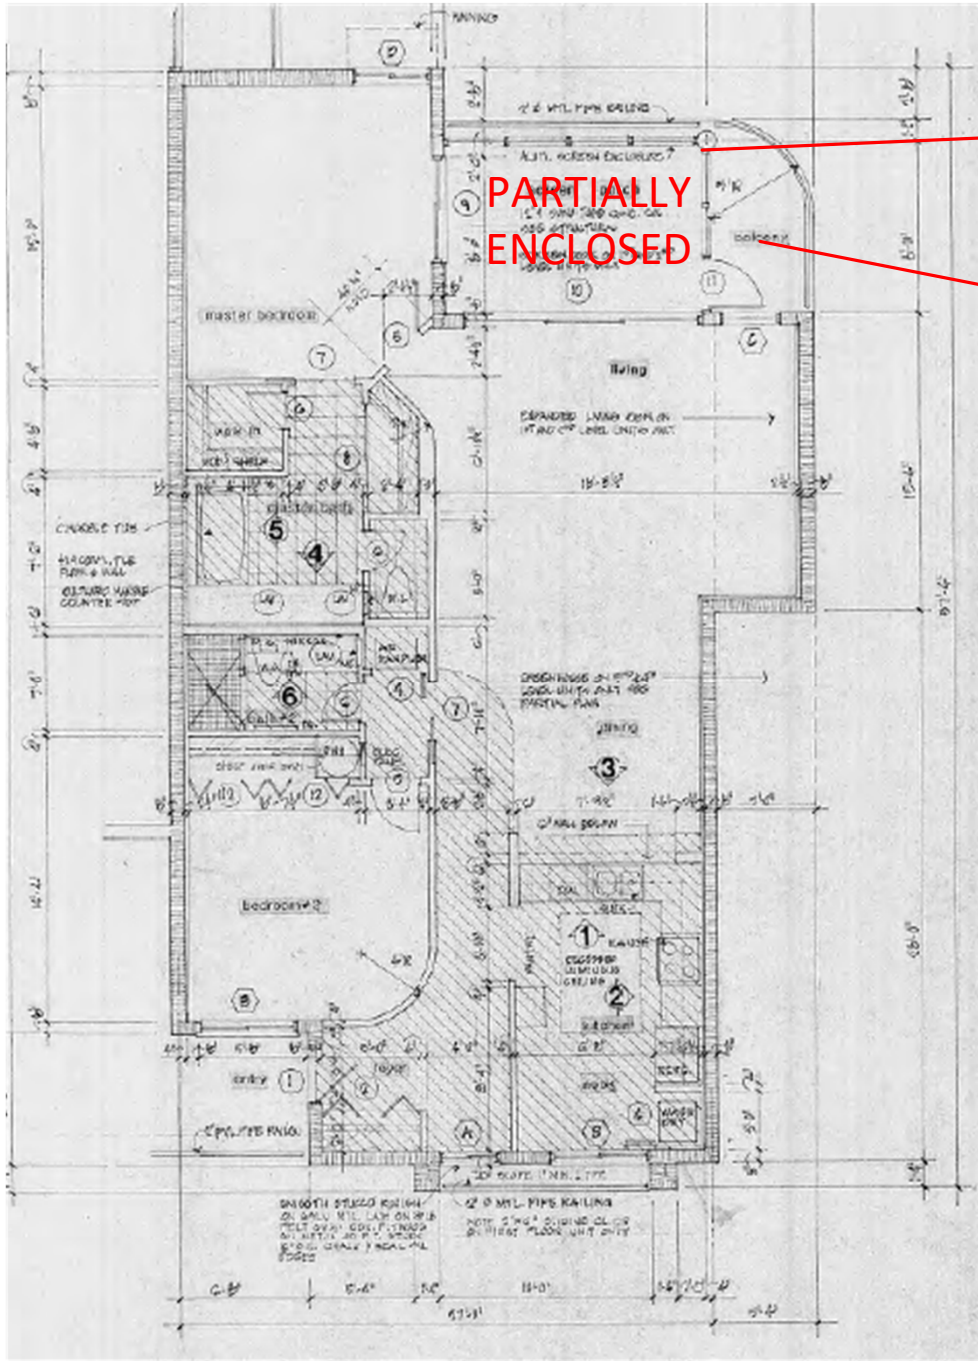
UNIT 241

Cracking observed on interior of round column

Peeling of waterproofing on side balcony

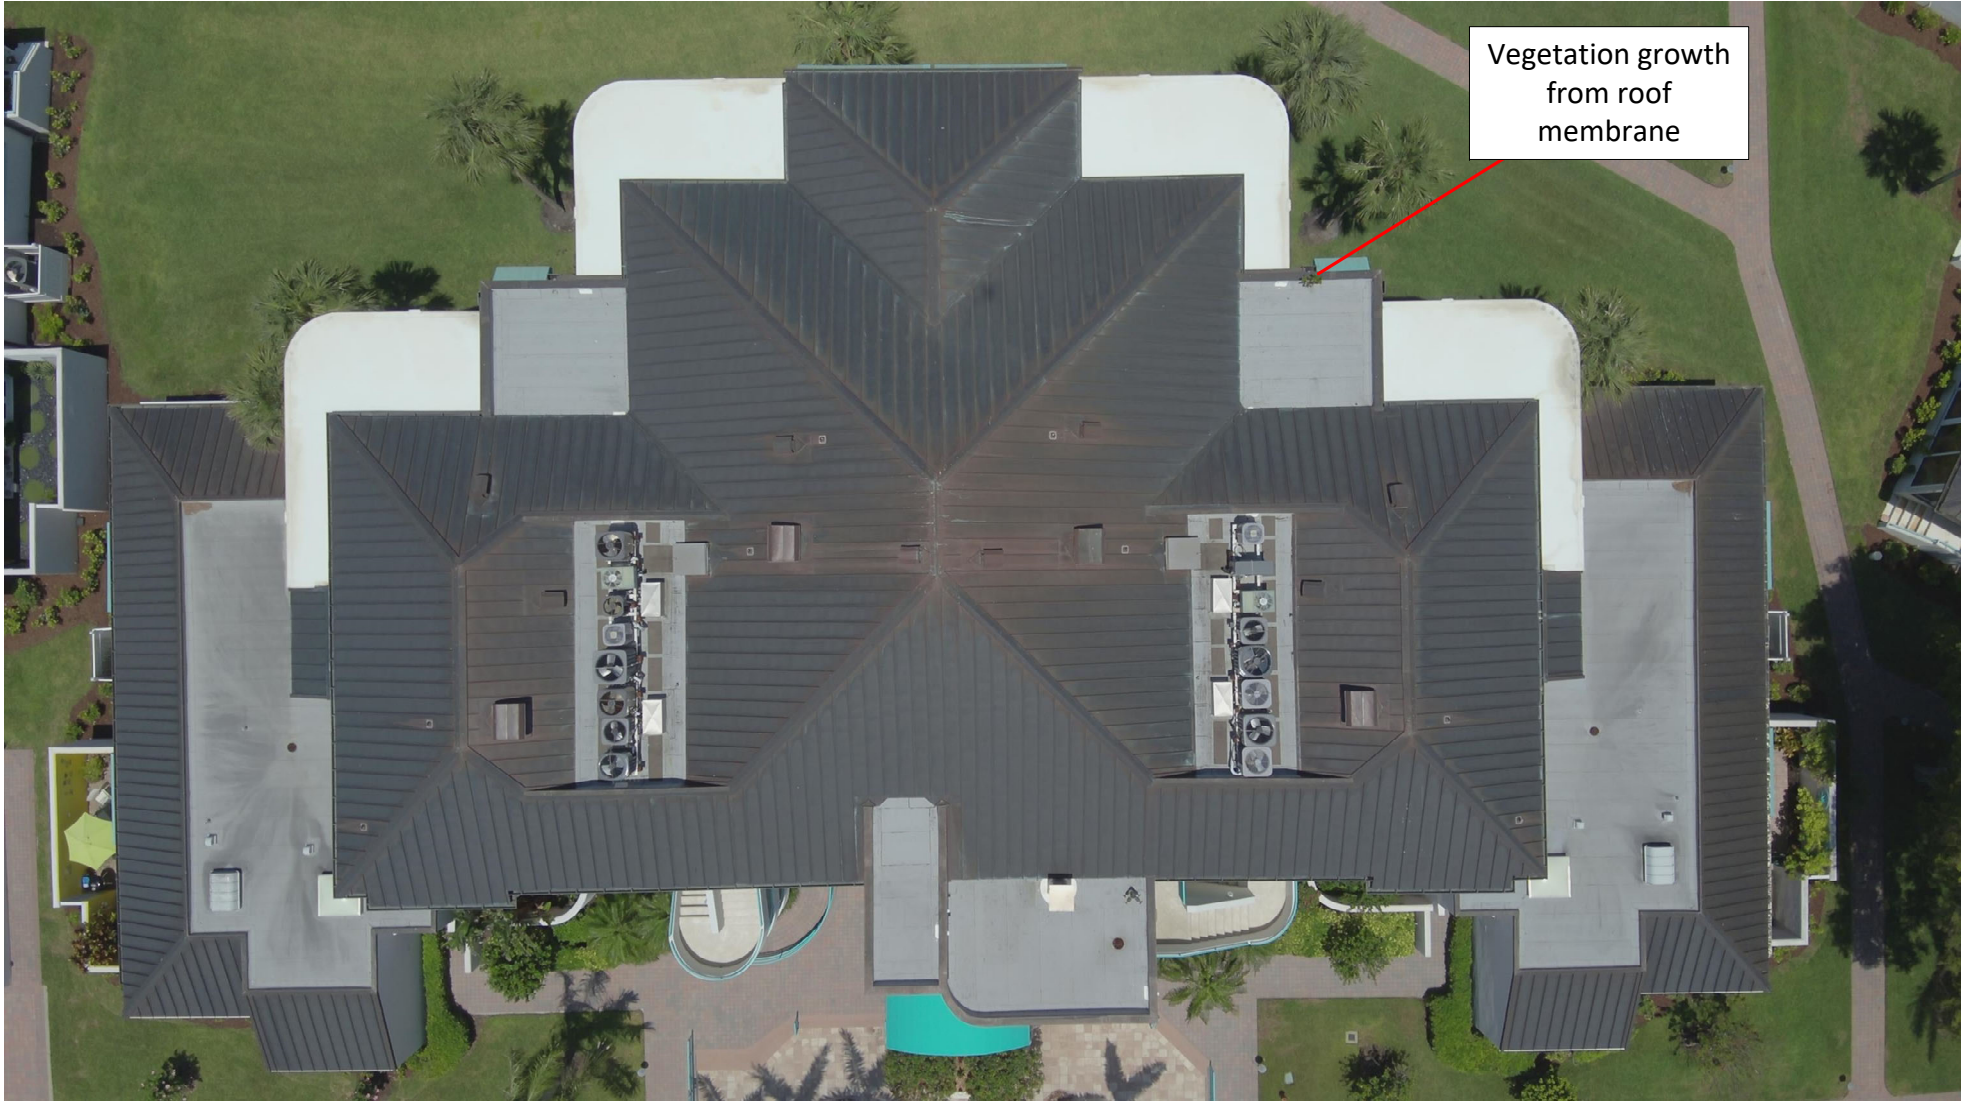
ROOF

Vegetation growth
from roof
membrane
