**PARK SHORE LANDINGS CONDOMINIUM ASSOCIATION, INC.**

**Subject:** Report of Engineering Consulting Services  
**MILESTONE INSPECTION – PHASE I**  
355 Park Shore Drive  
Naples, Collier County, FL 34103  
SOCOTEC Project Number VS233678

Park Shore Landings of Naples consists of four, 4-story residential structures which were constructed circa 1986 and is located within Naples, Collier County, Florida. The condominiums include a total of 72 individual units.

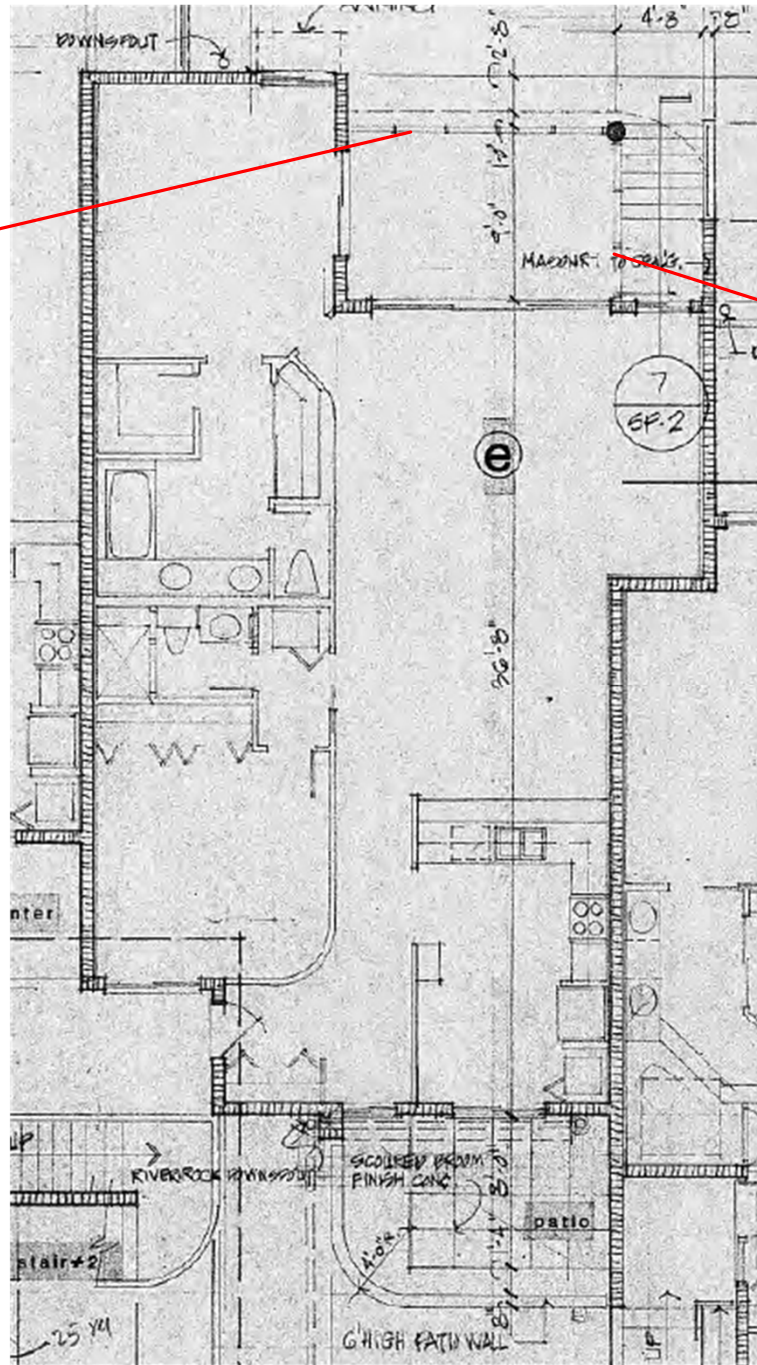
# UNIT 111

Peeling coating on screen enclosure

Corroded fasteners of screen enclosure

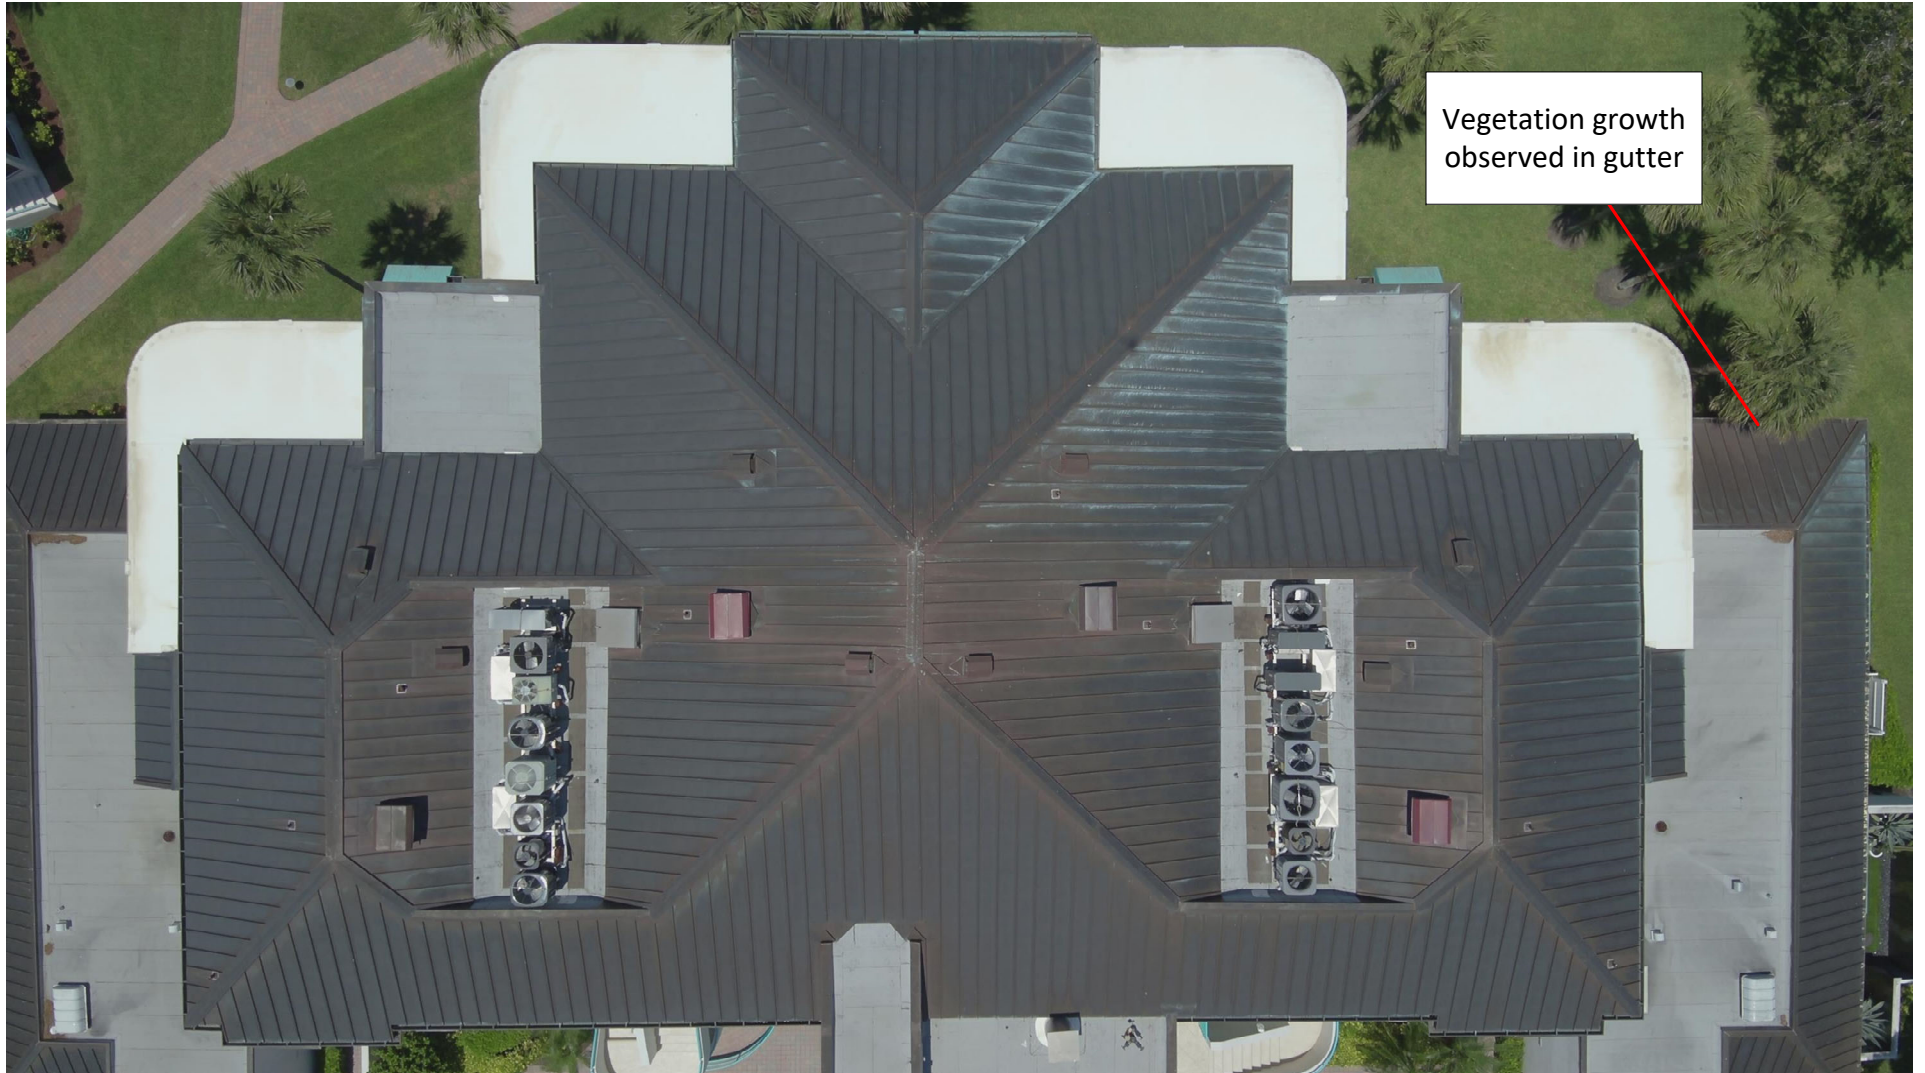
# ROOF

- Plant growth on roof and gutter.
- Corrosion at roof edge.
- Signs of previous staining on several balcony edges at the rear of the structure.
- Deck waterproofing and delaminated tiles.

Vegetation growth  
observed in gutter
